SUBJECT: Acceptance of Report entitled "Assessment of Critical Non-Compliant Sidewalks, Paths and Crossings"

ISSUE: The issue is whether or not to accept the report entitled "Assessment of Critical Non-Compliant Sidewalks, Paths and Crossings", by the CCRPC and the Toole Design Group.

## Essex, Vermont

Assessment of Critical Non-Compliant Sidewalks, Paths, and Crossing Memorandum

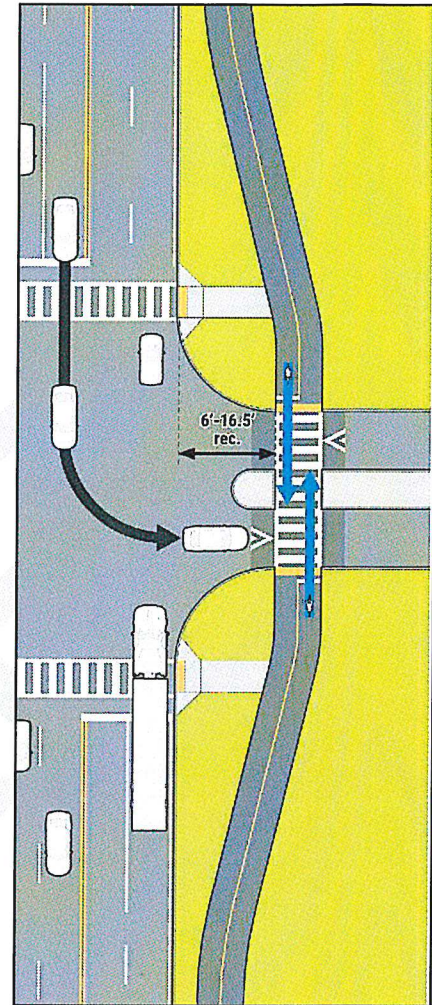
The intersection of Essex Way and VT Route 15 serves as a gateway to the large range of amenities available near Essex Way and forms the crossroads of several shared-use path connects in all directions. There is also a bus stop at the southeastern corner of the intersection that currently lacks a sidewalk or paved landing for loading and unloading wheelchairs from buses. The curb ramps at this intersection are constructed with bituminous pavement, some of which is in poor quality. None of the ramp designs meet current VTrans design standards. The intersection's large corner radii result in long crossing distances and create challenging constraints for implementing preferred accessible ramp designs. Due to the large corner radius on the southwestern corner, the existing crosswalk on the southern leg of the intersection has an irregularity midway across the street to bend around the raised median at the center of Essex Way. Crosswalks that are not straight, perpendicular to the crown of the roadway, and parallel to adjacent automobile traffic can be disorienting to people with visual impairments and also tend to have a longer crossing distance. If the large corner radius cannot be avoided—for example, if combination trailers must routinely turn right from VT Route 15 onto Essex Way—preferred crossing designs could still be achieved. One consideration would be to redesign the southeastern trail approach to be offset farther from VT Route 15. This would require a cut through in the existing median. The trail approach on the southwestern corner could also be modified to be offset less far from VT Route 15. By shifting the trail approaches and/or modifying the median, a straight crossing parallel to VT Route 15 is possible. Upgrading the ramps, median refuge, pedestrian signals, and bus stop at this intersection would not only benefit people with disabilities, but also trail users and transit riders of all ages and abilities.

Figure 3: Shared-Use Path crossing with cut through median island.

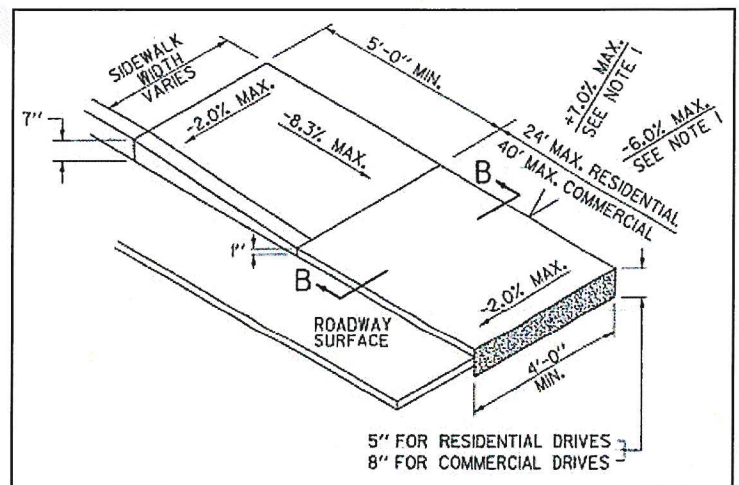
Figure 4: Parallel crossings should only be used on driveways that slope downhill from the street and care should be taken to avoid excessive cross slopes.

crossing with flare or jogged crossing (see VAOT Standard C-2A) would have been more appropriate given the grade change between the gutter and driveway. In these cases, the use of the parallel crossing design resulted in an excessive cross slope on the walkway.
